**ACCIDENT FINAL REPORT
PROBABLE CAUSE REPORT**

FILE No. **ACCDTARA004/2018MMPB**

Aircraft: Agusta Brand, Model A1095, Serial Number 22174, Registration XA-BON.

Date and Time: 02:35:40 p.m. (20:35:40 UTC); December 24th, 2018.

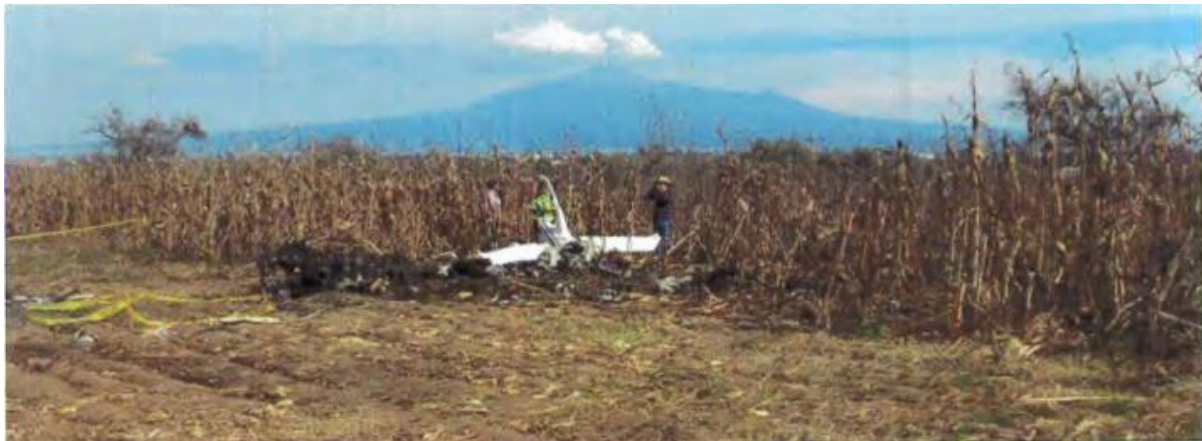
Fig. 7.7.3. The main remains were concentrated at a single point of impact, there was no ground displacement.

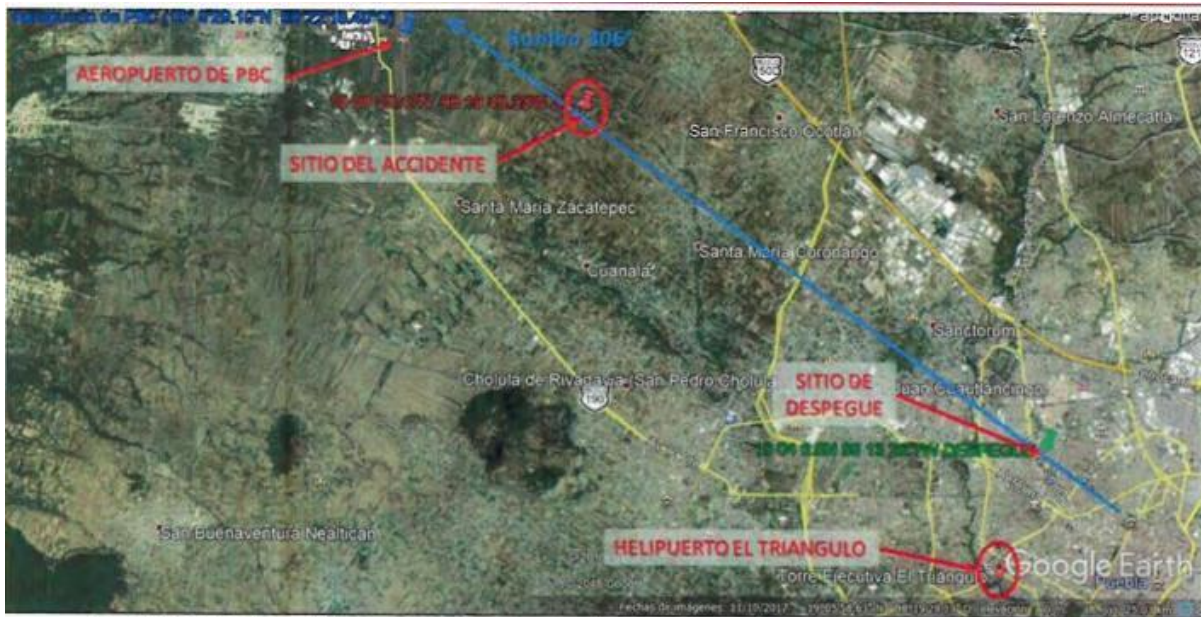
Fig. 1.1.4. Accident site, with respect to the house where the XA-BON landed and took off.

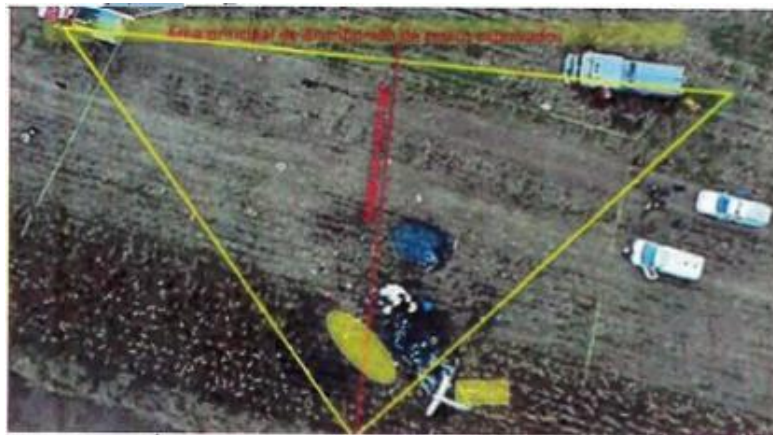
1.3.1 Helicopter remains dispersion area

Some small fragments of the helicopter were scattered over a triangular area of approximately 600 m² (6,460 ft²).

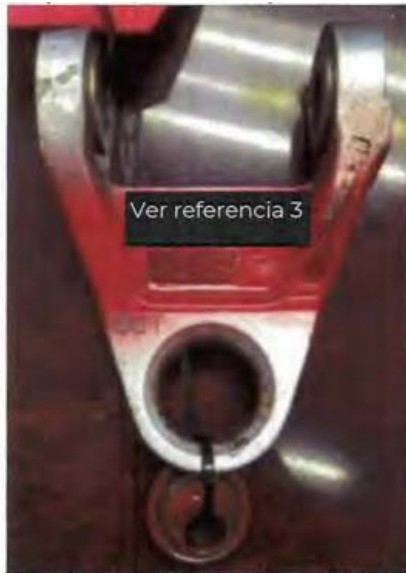
In this task, maintenance personnel removed 4 bushings (N/P 07-261-08-024), 2 shims (N/P 120-008C34E21), 1 rotary half scissor assy (N/P 109-0134-10-705), 1 sleeve (N/P 109-0110-69-107) and 1 sleeve (P/N 109-0110-69-105); these same components were installed as new, except for the rotary half-scissor which had a repaired condition, with its respective FAA Form 8130-3.

1.6.2.1. Half scissor removed on December 20, 2018 for excessive spherical bearing play.

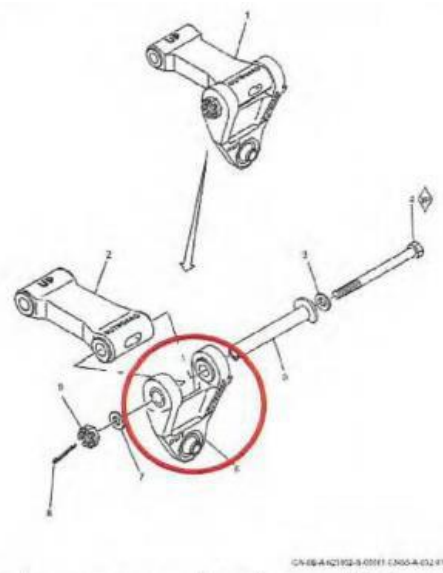
1.6.2.2. Image provided by the manufacturer of the removed part for further exemplification.

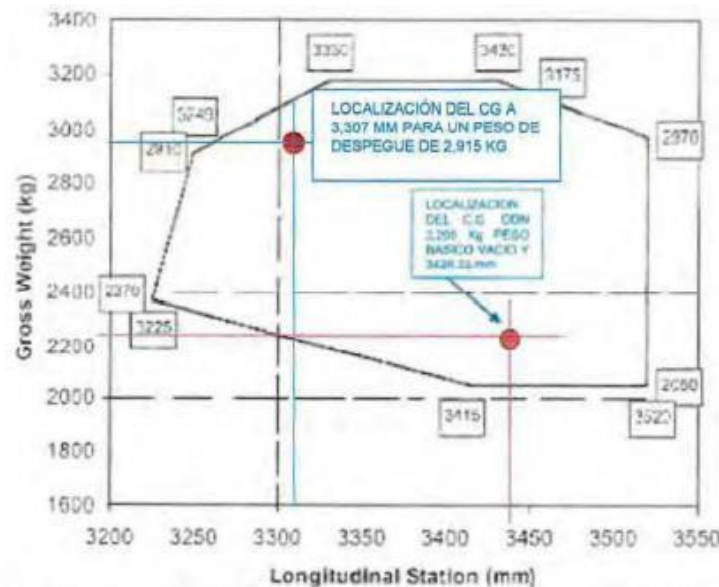
According to the referral dated December 24, 2018, the helicopter was supplied with the amount of 286 liters (225 kgs) of turbosine and considering the data that have been investigated, it was determined that one passenger was in the middle seat and two in the rear seat, with no luggage in the cargo compartment, so the Takeoff Weight (PD) was 2,915.0 Kgs and the center of gravity (CG) was 3,307.0 mm from Datum; concluding that the CG was within the flight envelope.

Fig. 1.6.4.1. CG enveloping with an empty weight and a take-off weight of 2,915 kg

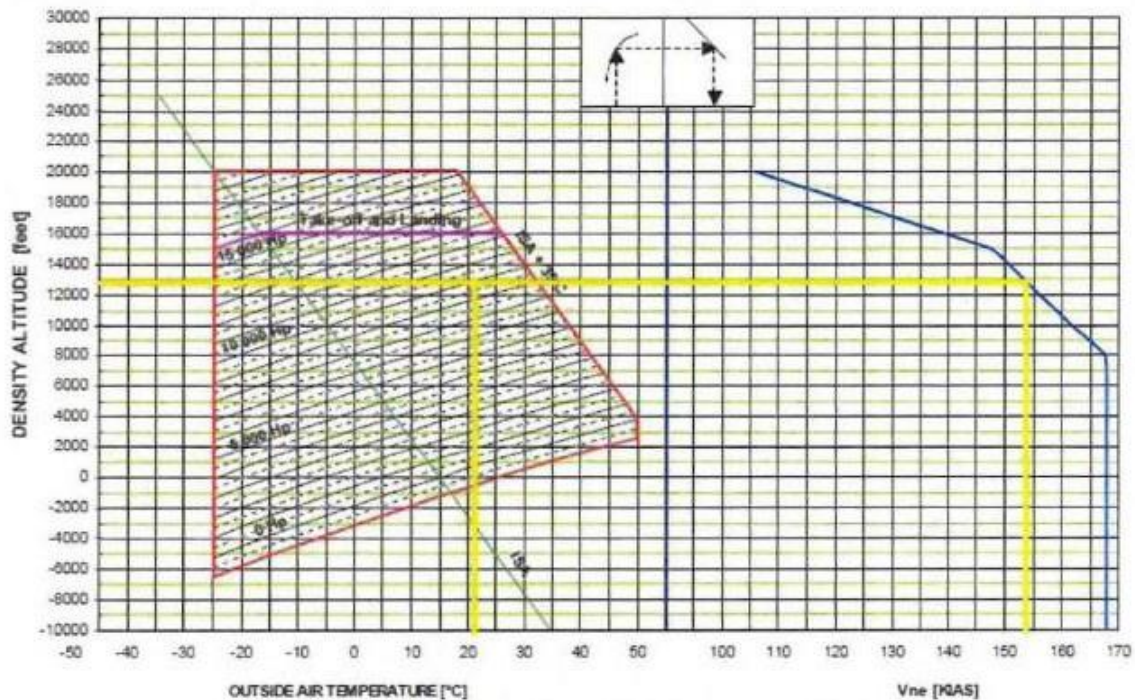
Considering the weather conditions and the operation data of the XA-BON helicopter mentioned above, with a cruise altitude of 2,895.6 m (9,500 ft.) proposed by the crew and corroborated by the radio altimeter reading, the ambient temperature of 21°C, obtained from METAR, according to graph 1-5 of the A109S Flight Manual, an equivalent altitude density of 3,810 m (12,500 ft) is obtained, to have a never exceed speed (Vne) of 154 knots.

Fig. 1.6.4.3. Graphic 1-5 Airspeed limitation Vne (Power-Gn)

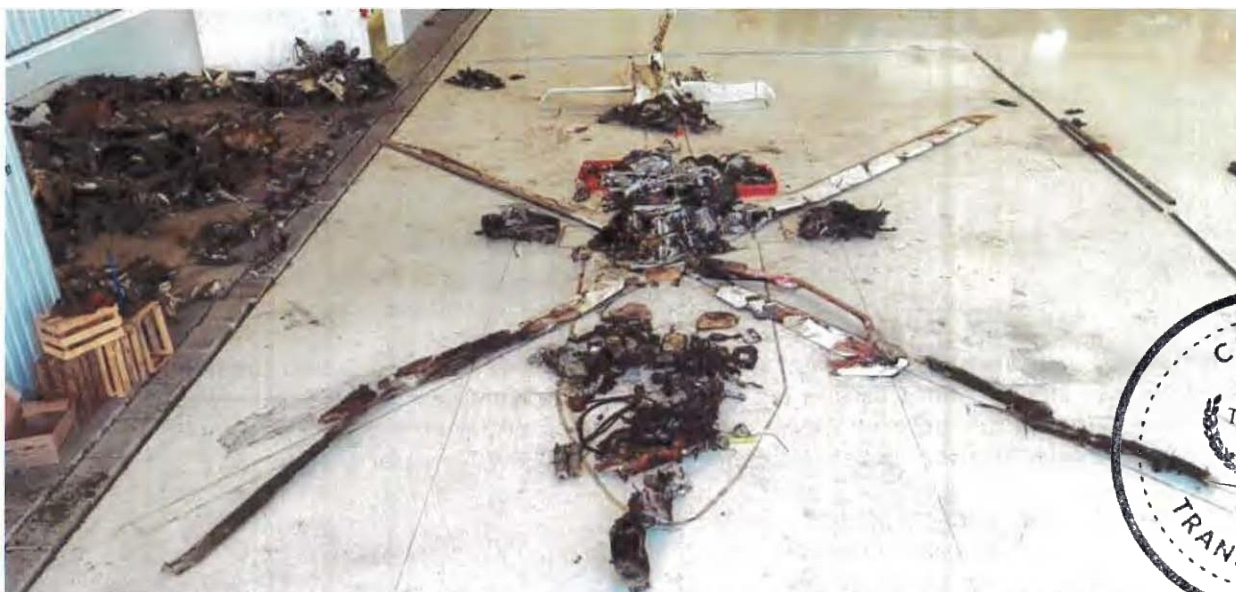
Fig. 1.15.2.1. Reconstruction of the helicopter with the remains of the main components.

The wreckage recovered at the accident site was placed in its design position, but given the destruction of the helicopter by fire, it was not possible to perform a detailed analysis of the structure of this section; however, the following was obtained:

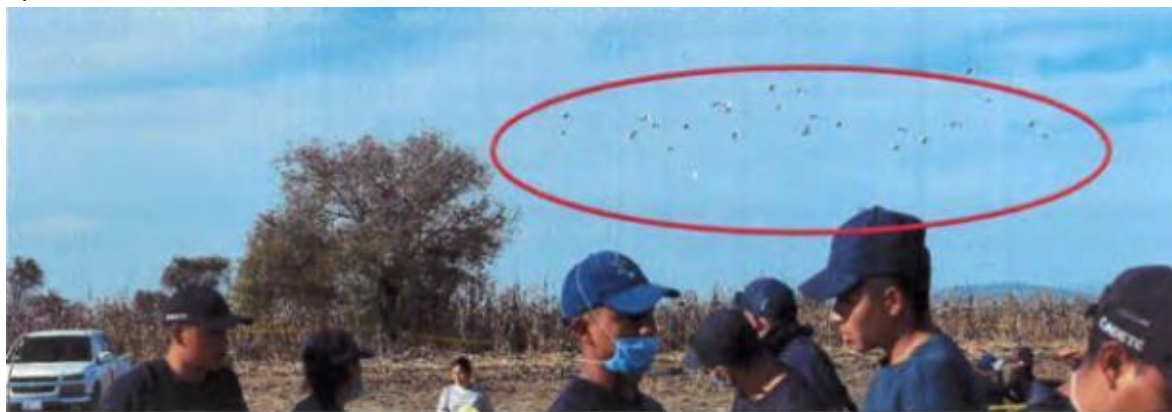
1.17.a. Presence of birds in the vicinity of the accident site.

During the field investigation, the presence of birds (white heron/great egret) was observed in the area of the XA-BON accident, so the possibility that one or more herons had impacted the cockpit or any of the components of the main rotor or its blades and caused the loss of control of the helicopter in flight was analyzed.

After analyzing the wreckage at the accident site, no evidence was detected that any of the crew members had been hit by a bird or object external to the parts of the helicopter registered as XA-BON; furthermore, there is no evidence of bird remains among the wreckage in the cockpit. Therefore, this hypothesis was ruled out as a possible cause of the accident or as a contributing factor.

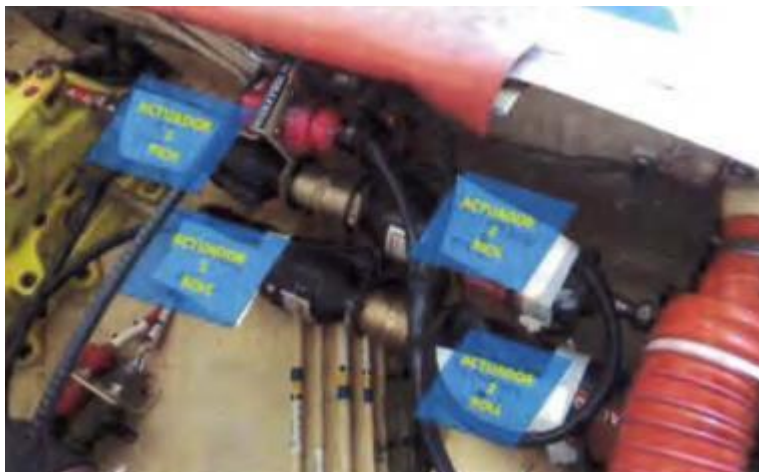
When the aircraft had a total time of 74.1 hours, the yaw actuator was replaced for the first and only time, and the roll linear actuator number two was replaced on two occasions starting in September 2017.

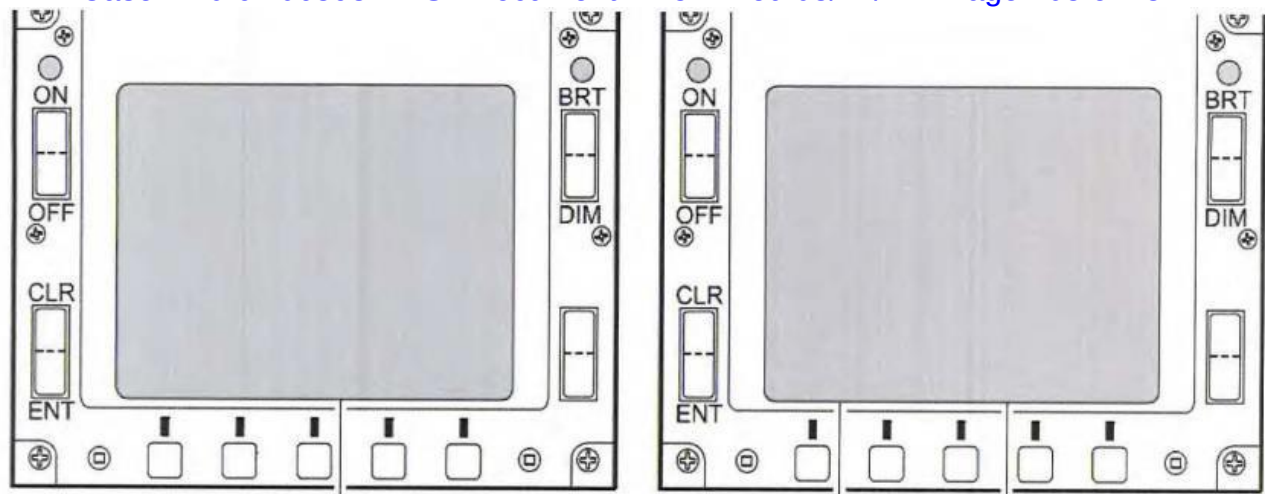
2 — **FD DCPLD**
1 — **AUTOTRIM OFF**

3 — **SAS 1 OFF** 4 — **SAS 2 OFF**
7 — **ATTD OFF** 5 — **VG 2**
6 — **VG 1**

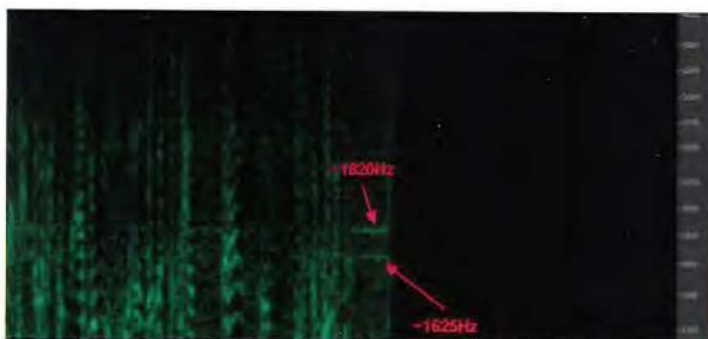
2.c. Audio from min 00:14:486

2.d. Fluctuation in main rotor rotational speed

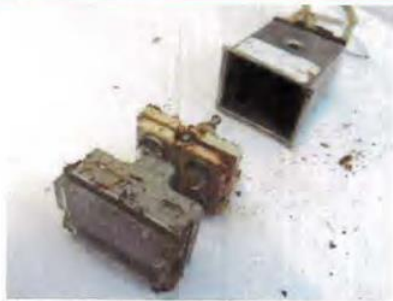
3.a. Master Caution with its bulbs in its interior

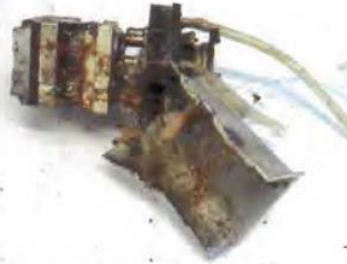
3.b. Master Warning with its bulbs in its interior

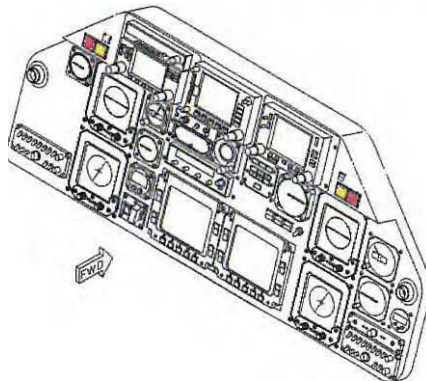
3.c. Location of Master Caution & Warning Lights on instrument panel

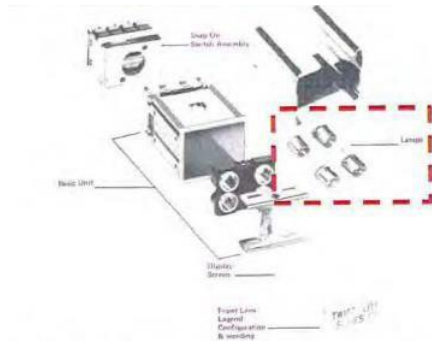
3.d. Location of bulbs inside the MC and MW lights

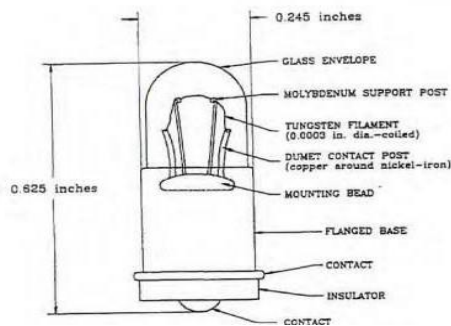
3.e. Characteristics of a type 327 bulb

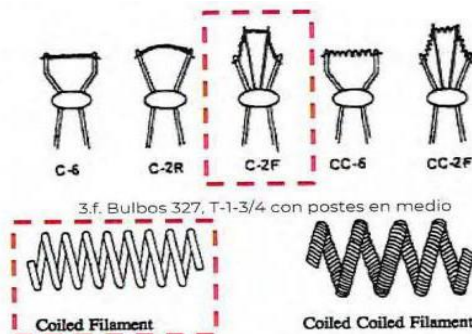
3.g. Filament type

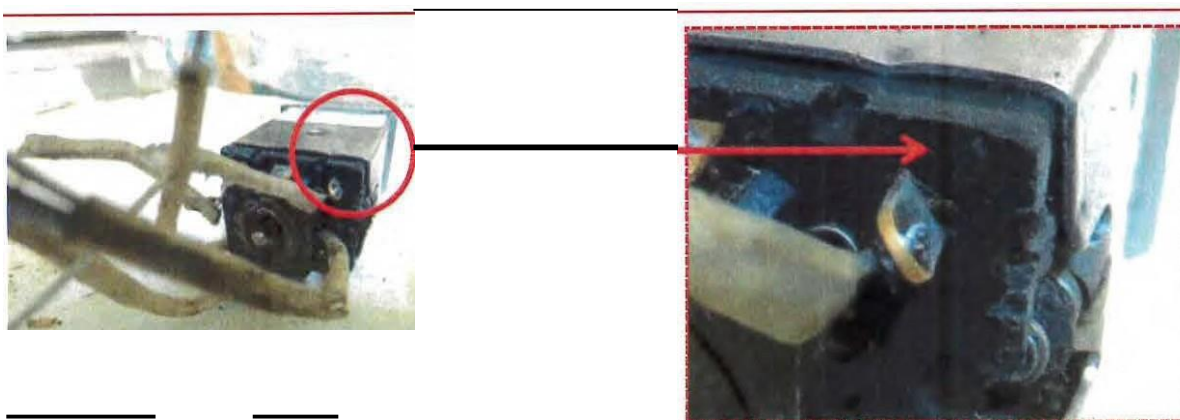
3.h. Location of MW and MC bulb position identifiers

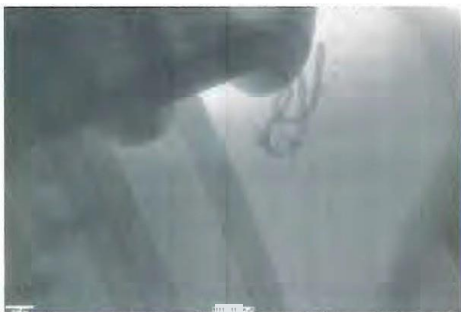
3.j. MW bulb B, the glass cover is intact, as well as the elongated filament.

All filaments are intact, except for MC bulb B, which shows a fracture. The fracture surface observed in the Scanning Electron Microscopy (SEM) shows a smooth and rounded appearance, indicating that the filament was hot at the time of impact. Although the investigation of the MC and MW indicator bulbs indicates that all 8 lamps were ON at the time of impact, it is important to consider the possibility that the initial impact may have caused electrical damage that changed the state of the bulbs, showing a false caution/warning indication that did not exist prior to impact.

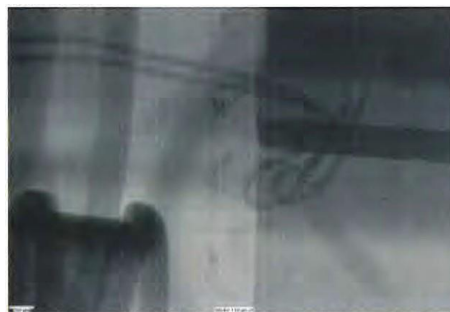
3.k. MC bulb B, the glass cover is intact, as well as the elongated filament.

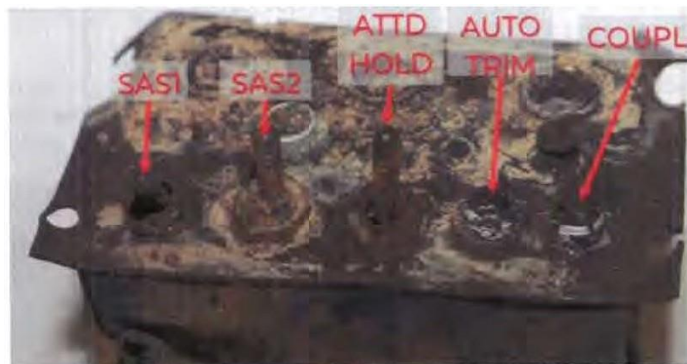
Of the five switches on the control panel, three switches remained on the control panel and two were not present. The three switches present are "SAS1", "SAS2", and "ATTD Hold". The "SAS1" was found to be in the OFF position. The "SAS2" and "ATTD Hold" were in the ON position. The "Auto Trim" and "Coupl/Decoupl" switches were not present. The "SAS1" switch could be pushed to the "ON" position but would not remain in that position as it automatically returned to the OFF position, this happens when no power is applied to the helicopter and this behavior is expected from this switch.

12.a. Helipilot Control Panel assembly with found configuration.

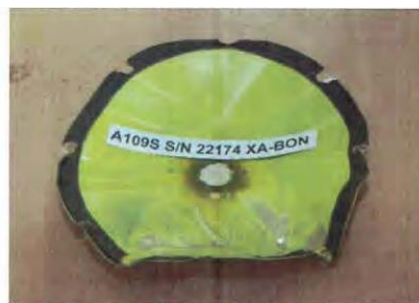
The first step in the inspection was the re-submission of the MVA cover, which had a bright yellow coloration on the inner surface consistent with the factory primer coating, and also showed bright silver colored scuff marks (aluminum metal under the primer application). There are dark colored marks around the contact marks (see image 1.3.a.). The cover was deformed upwards (see image 1.3.b).

During the disassembly of the deck, evidence of improper pre-torque installation on the deck could be seen because when the swashplate is installed without removing the MVA kit, the clearance between the rod head and the deck is greatly reduced causing the friction found inside the deck. Modular pattern⁴ of friction is related to oscillation.

1.3.a Internal surface of the cover

The friction found inside the cover is the result of the reduced space between the bar head and the cover.

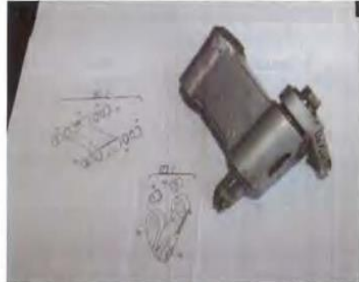
The Rotating scissor upper link remained attached to the swashplate hub. The upper link was removed from its design position. The swashplate hub exhibit bolt and the upper link were bent so it was necessary to use a sledgehammer to remove the bolt. The upper link exhibited very slight torsional deformation and the installation orientation labels were not observed however it displayed the following information:

1.4.2.a. Upper half of rotary scissors after disassembly

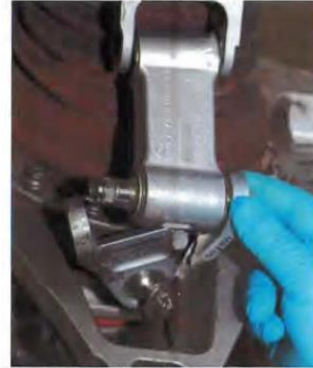
1.4.2.b. Rotating scissors before disassembly

The lower link of the rotating scissors was found in two pieces, one piece remained attached to the upper link of the rotating scissors (through the fixing screws) and the second piece remained attached to the rotating swashplate. The lower link could not be removed because it was deformed due to the impact against the ground. The fractures observed in the lower link pieces are consistent with a stress fracture. After removal of the rotating scissors, the swashplate assembly could be moved with the force of one hand in the lateral plane (forward, forward, right and left) without evidence of binding. The rotating swashplate could also be rotated manually in both forward and reverse directions. The fixed scissor link remained attached to both the fixed swashplate and the upper case of the main transmission.

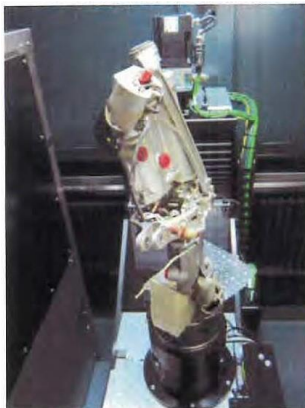
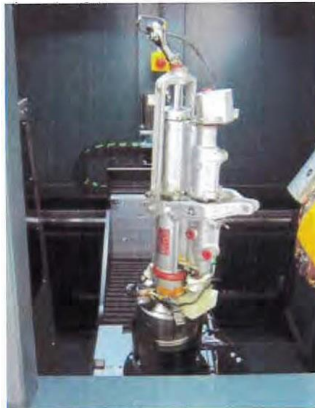
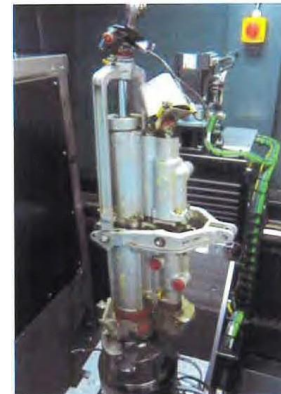
1.4.5.a. The three main rotor servo-actuators mounted on the scanner

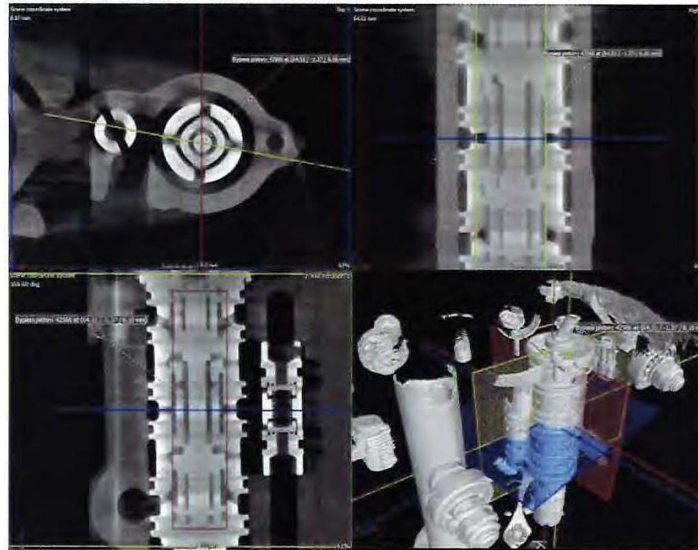
1.4.5.1.a. View of the 3D images of the lower part of the blue MRA

- The rest of the over-pass valve piston is intact, up to the connection with the extension.
- The servo-actuator piston is intact.
- The sleeve is intact.

- The pressure relief valve is intact.
- The extension was completely disconnected from the over-pass valve piston, as the microswitch case was crushed by impact forces against the ground.

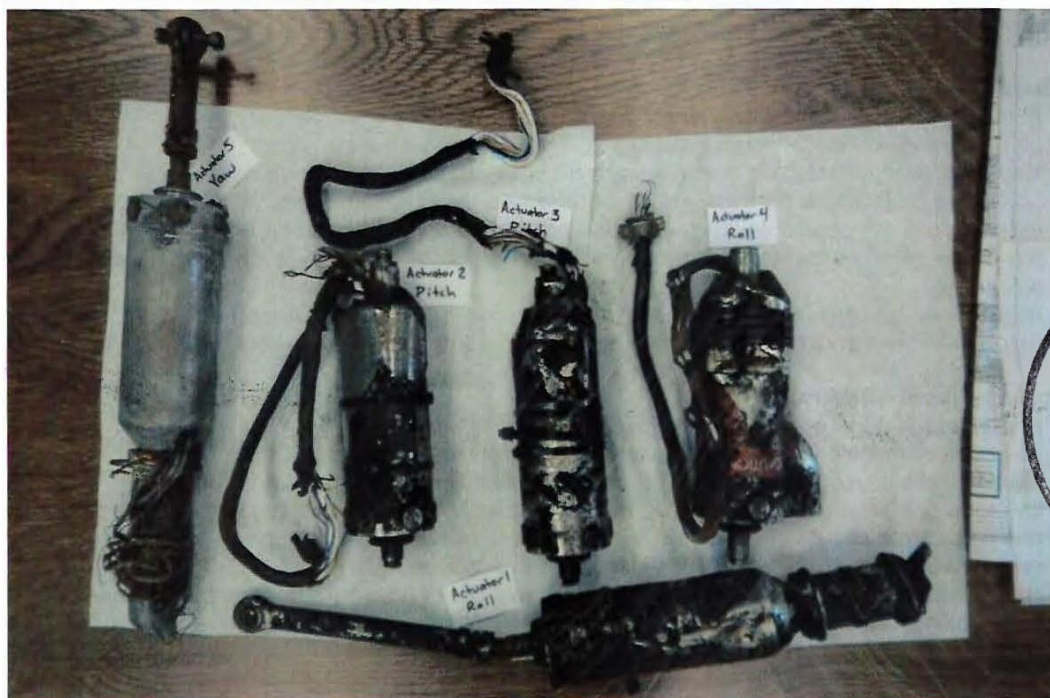
2.a The five electromechanical linear actuators as they were found

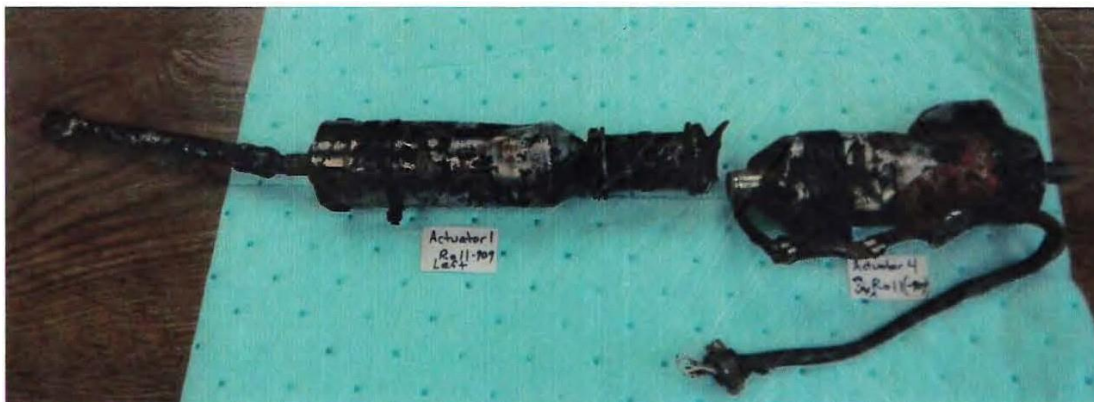
- Left Position (P/N 4012373-909) N/S 0908L409
- It still had the link terminal connected to its output end. The lock nut, (toothed washer) and lock washer (locking tab) were present, but the safety cable was missing.

2.1.a. Left (SAS1) and right (SAS2) linear roll actuators

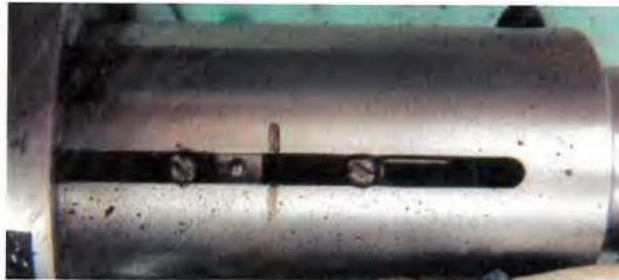
- The connecting tube remained attached to this actuator. A small portion of the right-hand linear actuator case (roll) was attached to the connecting tube. There was no safety wire in the connection nut of the connecting tube.
 - The connection tube was removed by Honeywell's expert.
 - The LVDT¹ was not protruding from the case and was not fractured.
 - The ball screw remained aligned with the alignment marks on the case.

2.1.b. The ball screw was observed in retracted position
